**RE: Request for Information (RFI) Pursuant to Section 308 of the Clean Water Act
Garlock Sealing Technologies (NY0000078)
Docket No. CWA-IR-15-023**

Compliance Evaluation Inspection: Garlock Sealing Technologies	
Inspection Date: February 27, 2015 Inspection Time: 9:00 AM – 1:45 PM	
EPA Inspector: Katherine Mann, Physical Scientist, USEPA Region 2, DECA, Water Compliance Branch, (212) 637-4226	
NYSDEC Representative: Nancy Rice, Environmental Engineer 1, Division of Water, NYSDEC Region 8, (585) 266-5453	
Site Representatives: David Samsonik, Manufacturing Supervisor, (315) 597-3057; Larry VanHoesen, Wastewater Operator, (315) 597-3392; Pete Orlando, Facilities Specialist; Carrie SanAngelo, EHS; Marc Rosen, Manufacturing Engineer	
Site Information: Garlock Sealing Technologies 1666 Division Street Palmyra, NY 14522 SPDES No. NY0000078	
Owner/Operator: Garlock Sealing Technologies, LLC 1666 Division Street Palmyra, NY 14522

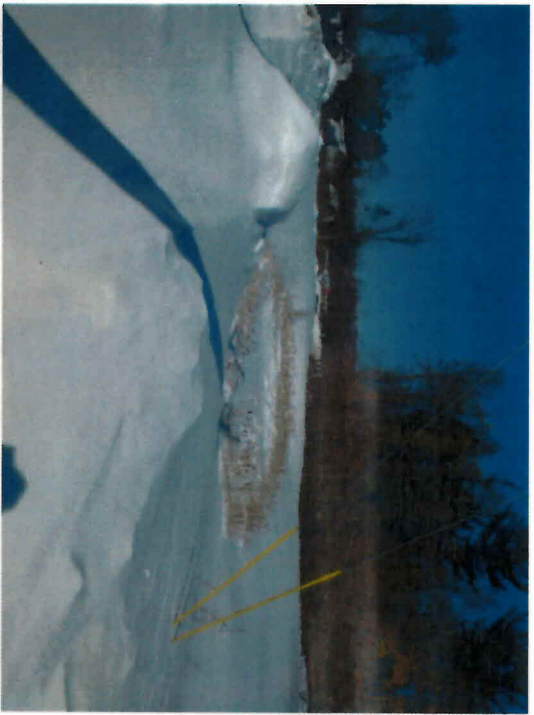
P2260001	Stormwater management pond (snow covered) near Outfall 018
P2260002	Ditch to Outfall 018
P2260008	Pumps conveying water from microcellular leach to the power house
P2260009	Outfall 013 (snow covered)
P2260011	Some of the waste streams draining to Outfall 008
P2260012	Waste streams draining to Outfall 008
P2270015	Drain in maintenance garage requiring BMP(s); absorbent pads upstream of the drain appeared to be saturated. Discharges to the drain do not flow through an oil and water separator prior to conveyance to the wastewater treatment plant.
P2270017	Catch basin upstream of Outfall 010
P2270019	Sludge holding tank at wastewater treatment plant – sludge pumped out twice per year and transported to the Ontario or Canandaigua wastewater treatment plants; last pumped-out in December 2014
P2270021	Final effluent from wastewater treatment plant (~24 gpm) (flows to Outfall 011)
P2270023	Outfall 017 frozen and snow covered

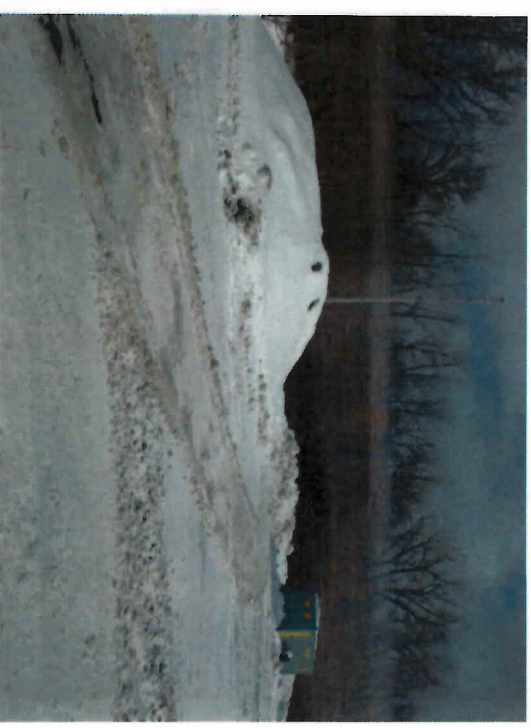
P2270024	Snow-covered asphalt pile located near outfall 017; all other stockpiles had been removed at the time of the CEI. No catch basins were observed in the immediate vicinity.
P2270025	Uncovered dumpsters for trash and rubber located on the east side of the Site. At the time of the CEI, no catch basins were observed downstream of this location; however, stormwater runoff draining to the catch basins in the parking lot near the dumpsters drains to Outfall 017.
P2270026	Snow covered catch basin with filter fabric in the parking lot draining to Outfall 017
P2270028	Sump/containment pit collecting oily water from the ~30' press in the Mill & Calendar building. Oily water is pumped from the pit to the oil/water separator.
P2270029	Oil/water separator with scraper tube that draws out oil and transports it to a 55-gallon drum. According to the March 30, 2015 email from Ms. SanAngelo, the facility collects approximately one (1) 55-gallon drum of oil from the oil/water separator per month.

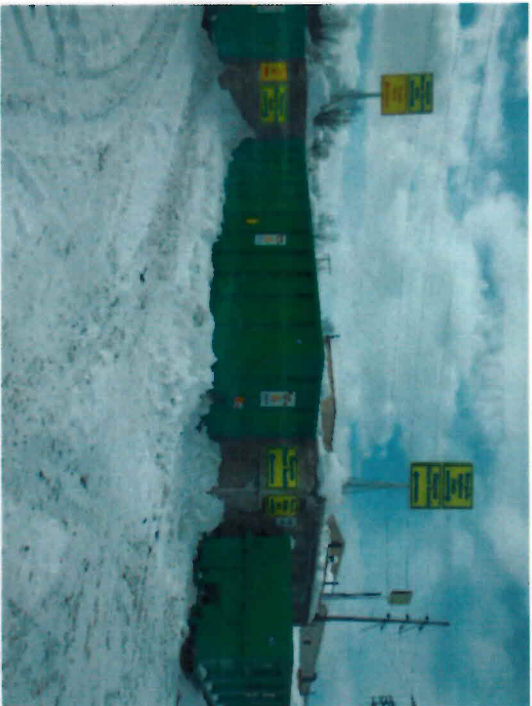
P2270025

5. As identified in photograph P2270025, uncovered dumpsters for rubber and trash collection were identified on the east side of the Facility. Although no catch basins were observed in the immediate downstream vicinity of the dumpsters at the time of the CEI, catch basin in the parking lot near the dumpsters drain to Outfall 017. Dumpsters containing waste materials such as rubber and trash should be covered in order to prevent exposure to stormwater and the transport of pollutants to surface water bodies.

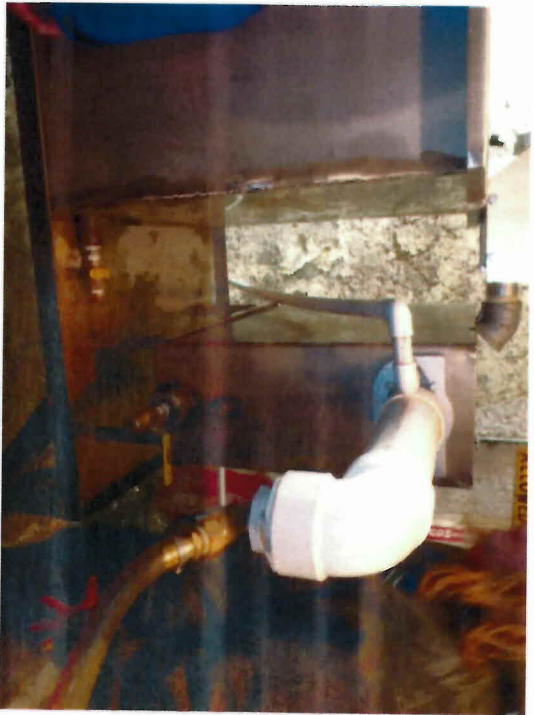
P2270030	2" pipe that directs water collected from the oil/water separator to a floor trough/drain, which ultimately transports it to the wastewater treatment plant
P2270031	Pipe conveying water from the oil/water separator with discharge to a trough. According to Facility representatives, and identified on the site drainage map provided, there is a floor drain in the trough that conveys the water to the wastewater treatment plant.
